# Cartographic support at 1917 Brežice earthquake study

Dušan Petrovič, Marko Berus, Anka Lisec, University of Ljubljana, Faculty of Civil and Geodetic Engineering

Ina Cecić, Slovenian Environment Agency

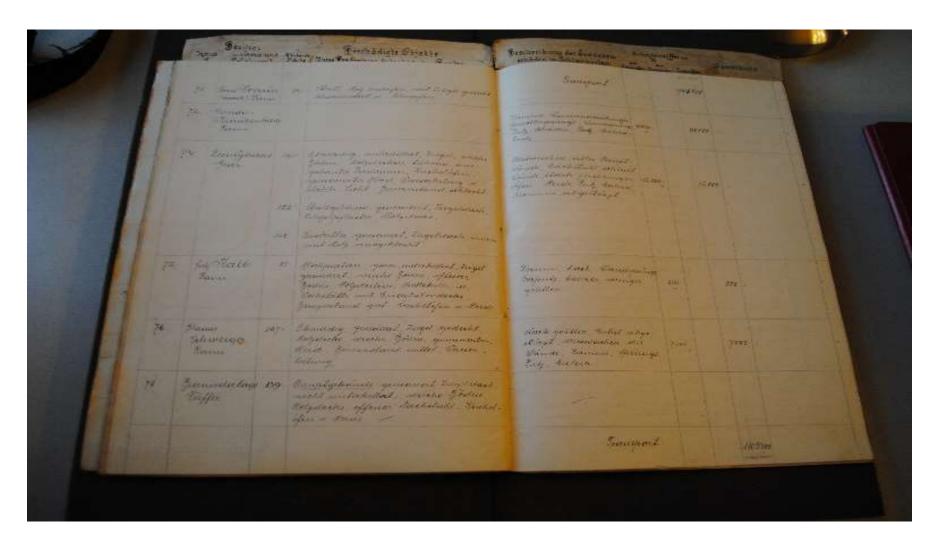
inventory upgraded with estimated vulnerability assessment and damage of the affected objects, Slovenian Environmental Agency

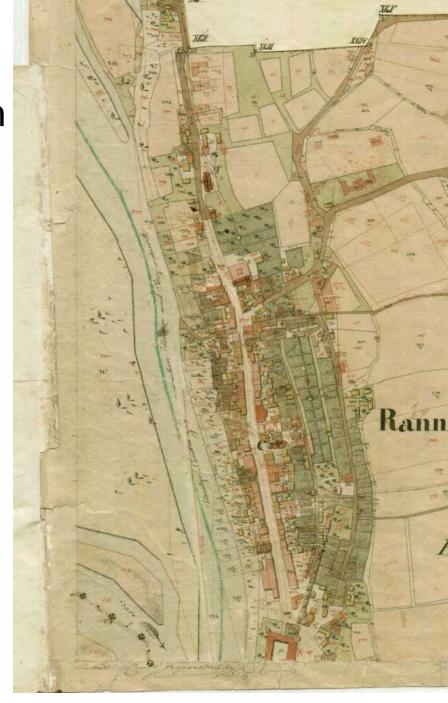
- map of that time situation
- re-embedded Franciscan
   cadastre plan (1860 70)
- georeferencing

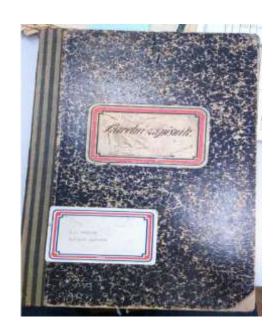
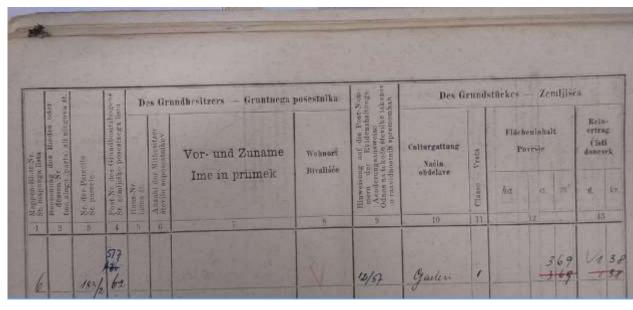
parcel record of the land cadastre, acquired in the archives of Cadastre office in Brežice

Identification of the buildings from the inventory to the cadastral plan were made with 94% successfulness degree of vulnerability (EMS-98)

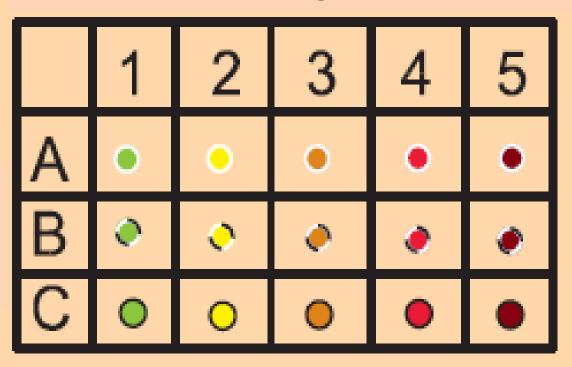
To archive good visibility and understanding: combined both attributes in one single map symbol

level of damage

degree of vulnerability

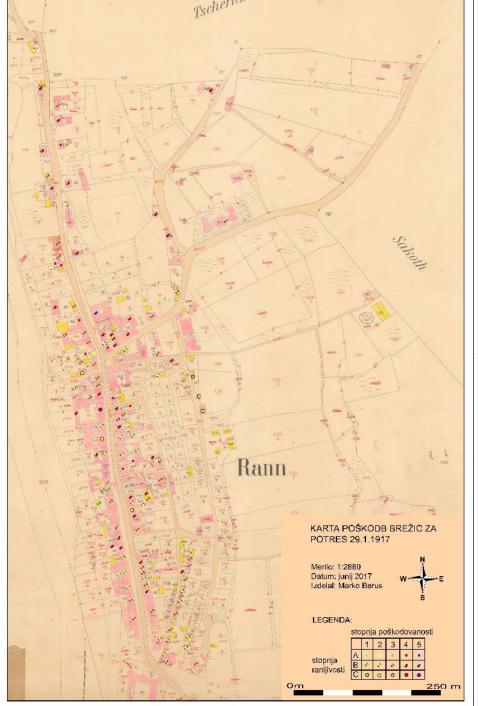
90% of all buildings at least partly damaged, 73% of all buildings moderately to severely structurally damaged
